### COOPERATIVE SEDIMENTATION SURVEY OF LAKE GUAYABAL

PUERTO RICO WATER RESOURCES AUTHORITY

BUREAU OF RECLAMATION

January, 1965 (2nd run) United States
Department of
Agriculture

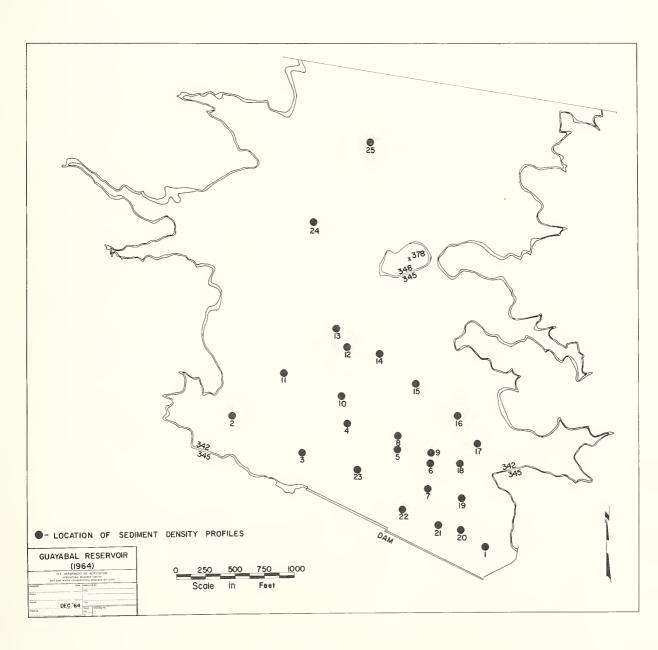
Measurements of sediment density were made at selected sites. These sites are shown on the accompanying sketch map of Lake Guayabal (Figure 12). Twenty-seven positions are reported. The maximum (wet) density measured in the lower pool was 1.626 g./cc.; 52.5 feet below the water surface, 7 feet below the sediment surface; at position four. A high density of 1.940 g./cc. was obtained at site 27, in the Toa Vaca River delta. This high density is associated with the sands and gravels of the delta deposits (Table 2).

Figure 12. -- Outline map of Lake Guayabal showing location of sediment density profiles measured with the gamma probe in October 1964.
